PLMI

1346 km of overhead transmission lines inspected in 15 days

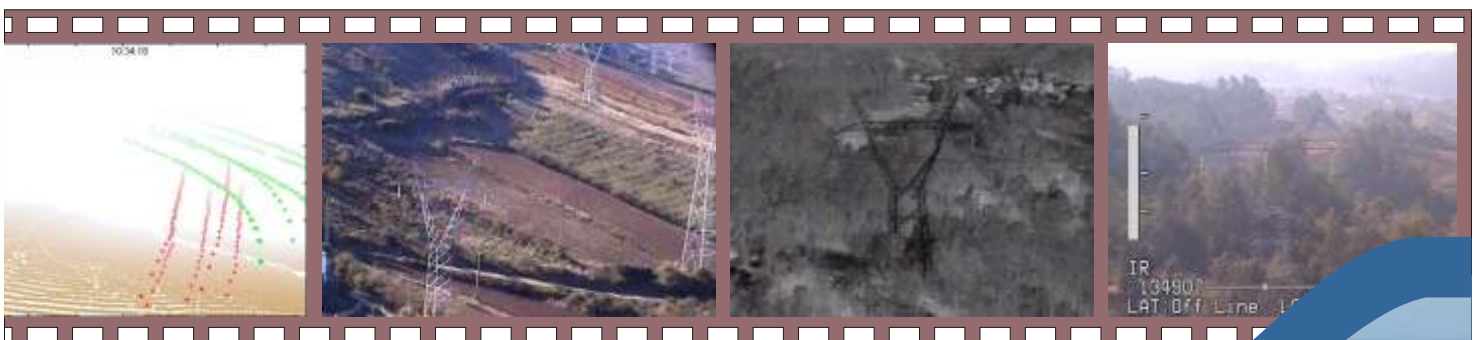
Line crossing reconstruction (LIDAR and image)

Thermography and video synchronization

The inspection missions included conductor anomaly detection using thermographic image (infrared) analysis, physical anomaly registration using video images and track clearance inspection using a LIDAR laser. The inspections were performed in 150, 220 and 400 kV lines, corresponding to 19% of the entire Portuguese transmission grid. The three types of inspections were performed simultaneously, using a helicopter

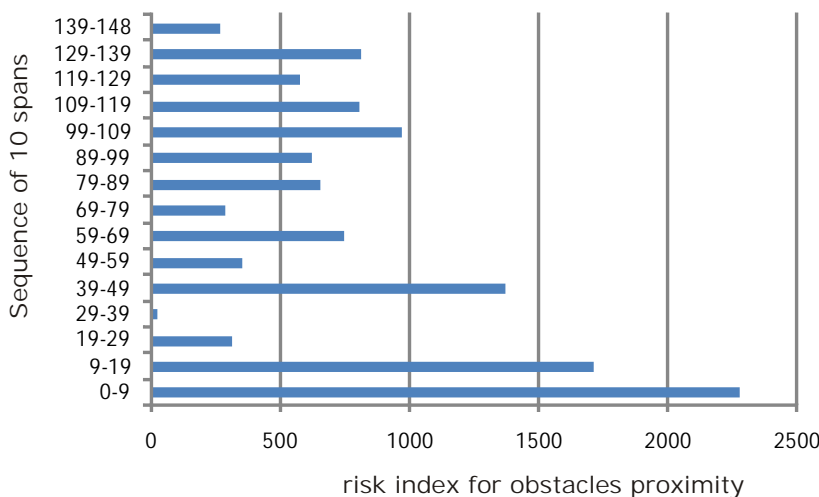
Accidental interruption risk due to vegetation, for a 60 kV line with 148 spans.

Consider the risk analysis of accidental interruption as a result of conductor proximity to obstacles in a 60 kV over head power line with 148 spans. This risk is associated with phase-ground defects triggered by vegetation near the power line. By inspecting the power line, a risk index can be determined based on the proximity of the conductors to obstacles along the track and the minimum distances specified in the regulations. By summing the risk index over every ten scans, it can be concluded that by taking preventive measures in spans 1-9, 9-19 and 39-49, which represent 20% of the total line, the risk index of the entire line can be reduced by 50%. The inspection also supplies the exact location of the obstacles that pose the greatest risk in order to correctively address the situation.

In this manner, the time spent in correcting the situation by maintenance teams is minimised and risk reduction is maximised simultaneously.
